# Test Report

**Test Item:** ALERTA Transit  
Manual, folding, transit wheelchair

**Test** ISO 7176-19:2008 as amended by  
EN 12183:2014

**Millbrook Report No.** 17/1184

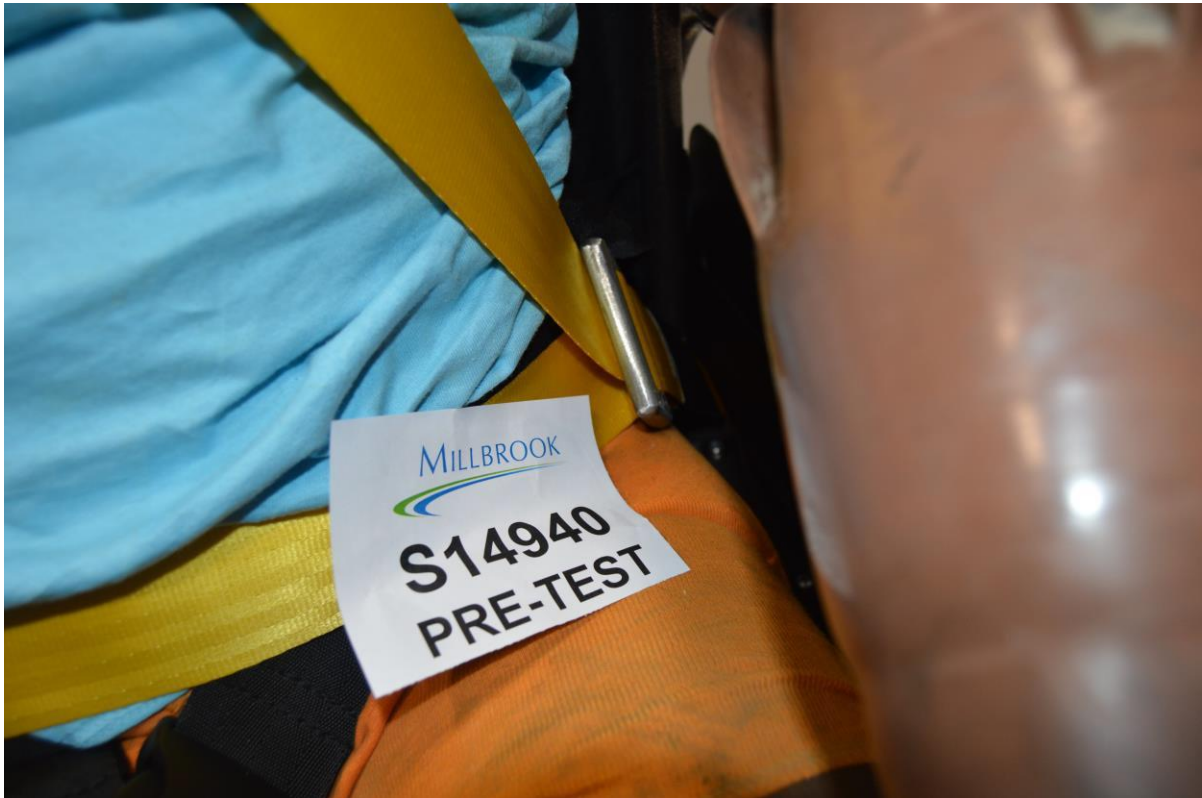
Note 1: Lap belt routing under arm support and skirt guard required to achieve effective location of lap belt.

Lap belt position, pre-test

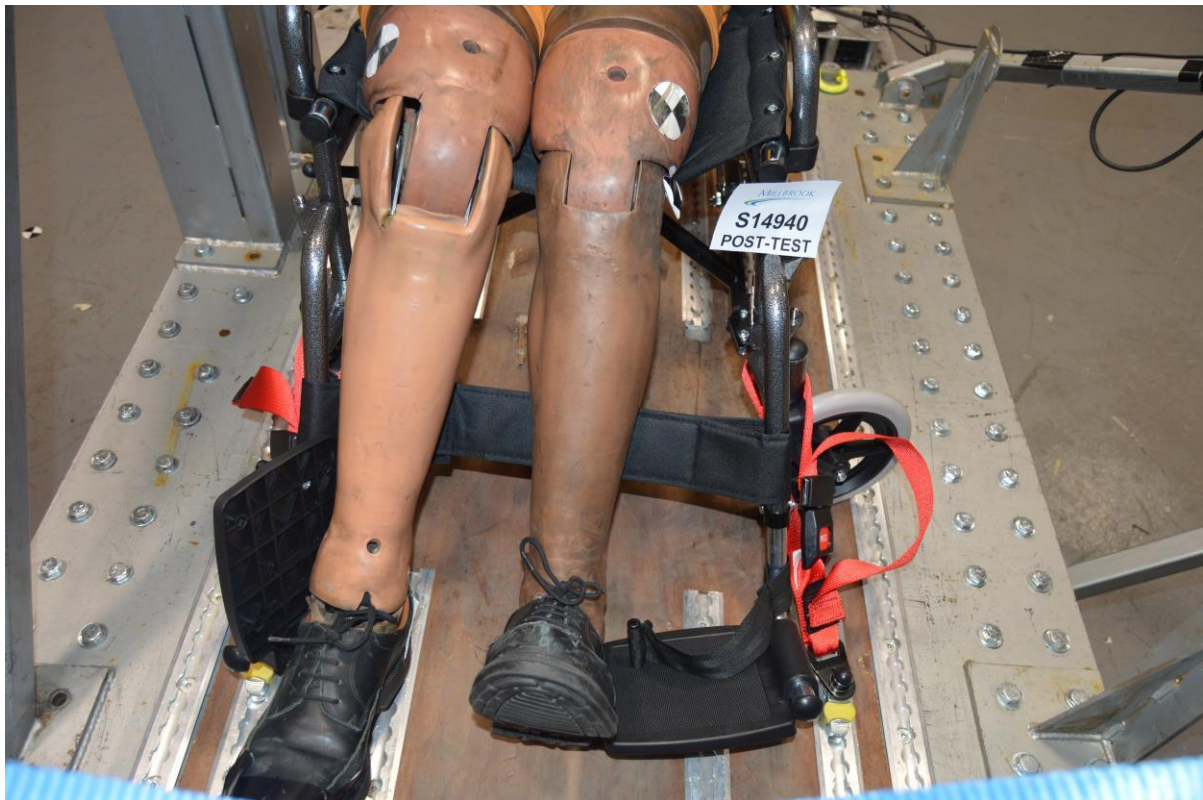
Front tie-downs, post-test

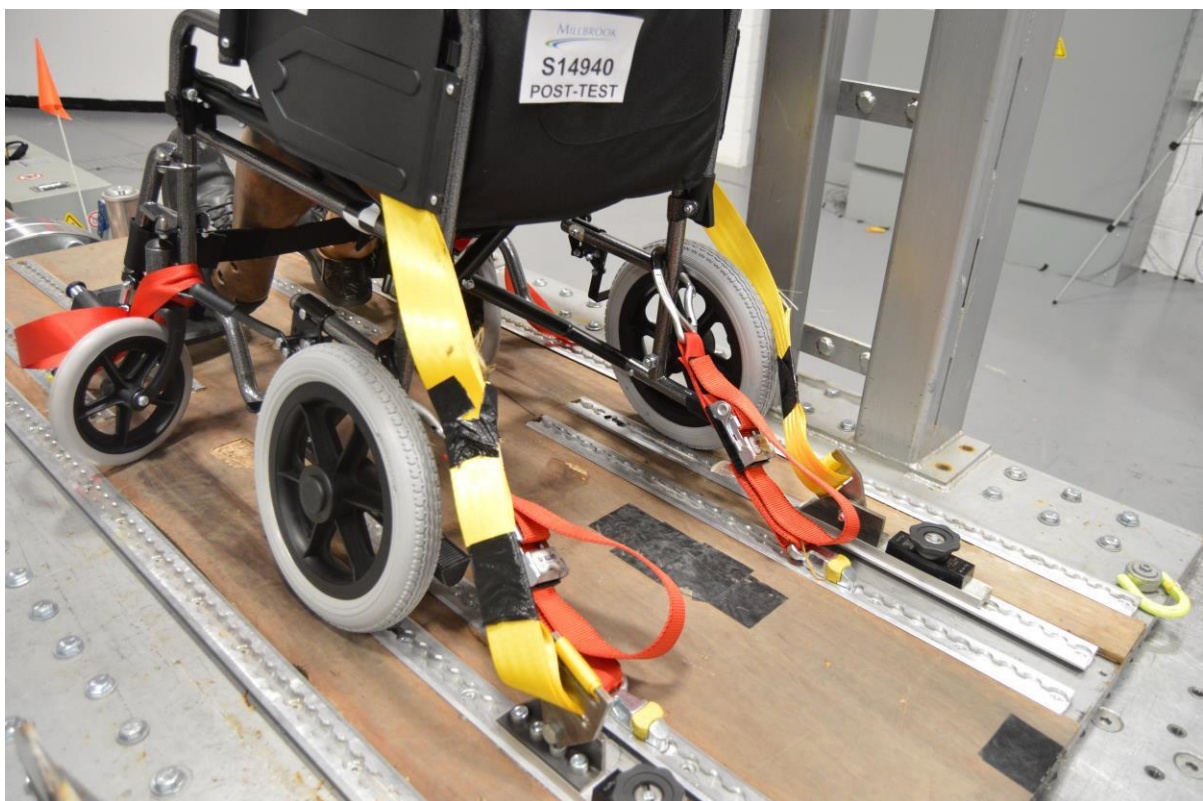
Rear tie-downs, post-test
